NEW MEXICO ENVIRONMENT DEPARTMENT

Re: BNSF Railway Company / Belen Yard; MSGP; SIC 4011; NPDES Compliance Evaluation Inspection (CEI); NPDES Tracking No. NMR053334; November 14 & 15, 2018

NPDES Compliance Inspection Report

On November 14 and 15, 2018, an announced National Pollutant Discharge Elimination System (NPDES) Compliance Evaluation Inspection (CEI) was conducted by Erin S. Trujillo of the State of New Mexico Environment Department (NMED), Surface Water Quality Bureau (SWQB), accompanied by Kate Herrell, NMED Ground Water Quality Bureau (GWQB), at the BNSF Railway Company, Belen Yard, 106 North First Street, Belen, New Mexico 87002 in Valencia County.

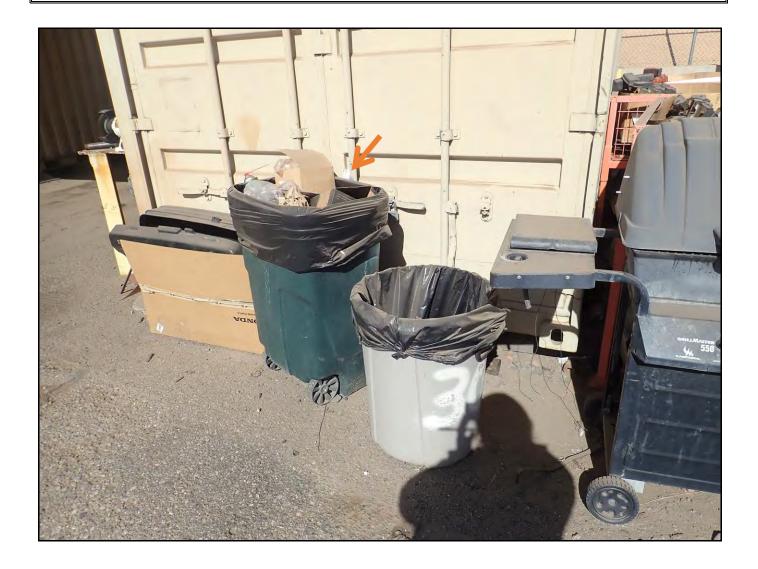
Subject: At the ATV vehicle and equipment maintenance area, trash containers are lined, but not covered. Arrow points

to trash level above the top of the container.

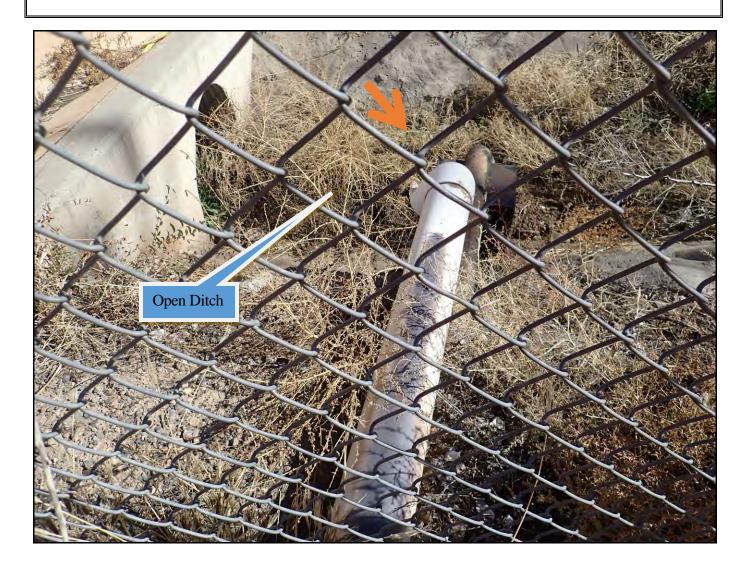
NMED/SWQB			
Official Photograph Log			
Photo # 2

Subject: Arrow points to stormwater pipe outlet outside the fence at northeast corner of facility described as Outfall 003 in Facility's Notice of Intent (NOI); labeled Outfall 1 on SWPPP maps; and labeled Outfall 3 on SPCC maps. Below the pipe outlet, the sides of the open ditch, which is MRGCD facility Santa Fe Ditch, are lined. No scour below the pipe outlet was observed.

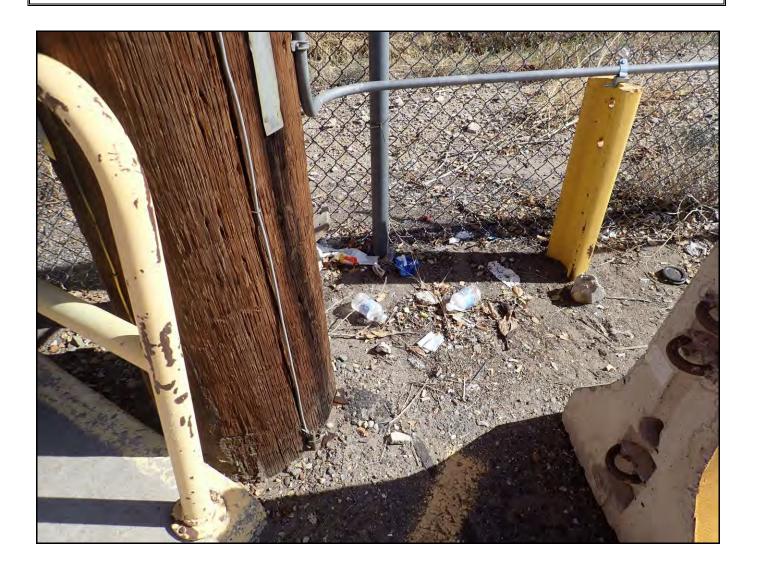
NMED/SWQB
Official Photograph Log
Photo #3

Subject: Example of plastic bottle and trash debris inside fence in northeast corner of the facility. The direction of runoff from this area appears to the west toward the stormwater drain inlets, lift station, surge tank, then pipe outlet in Photo #3.

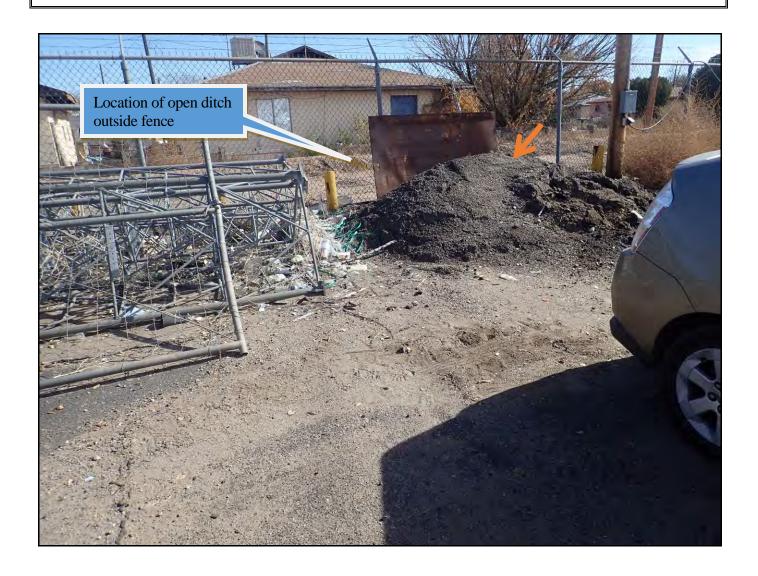
NMED/SWQB Official Photograph Log Photo # 4

Subject: More examples of plastic trash and debris in the northeast portion of the facility. Arrow points to material stockpile. The open ditch, which is MRGCD Santa Fe Dicth, is below this area (not visible in photo). The direction of runoff from this area appears to the west toward the stormwater drain inlets, lift station, surge tank, then pipe outlet in Photo #2. It was not determined during this inspection if the trash, debris and material stockpile is from industrial activity, but drainage from this area would appear to mix with storm water drained from the ATV vehicle and equipment maintenance area at the stormwater drain inlets, lift station, surge tank, then pipe outlet shown in Photo #3.

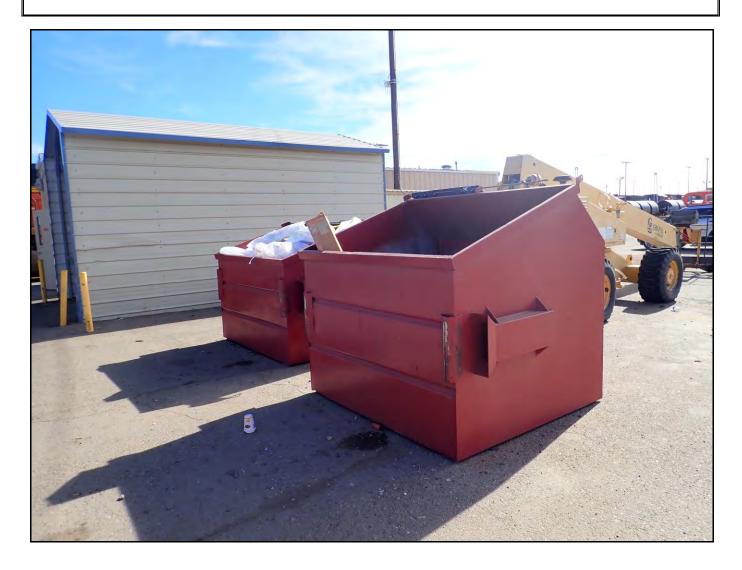
NMED/SWQB
Official Photograph Log
Photo # 5

Subject: Example of trash dumpsters that were not covered at West Bound Fueling Facility Rack (FA1). Bagged trash in dumpsters may minimize wind blow trash at the facility. Some trash and staining was on ground at dumpsters. It was not determined during this inspection if the dumpsters are solely used as control measures for industrial activity.

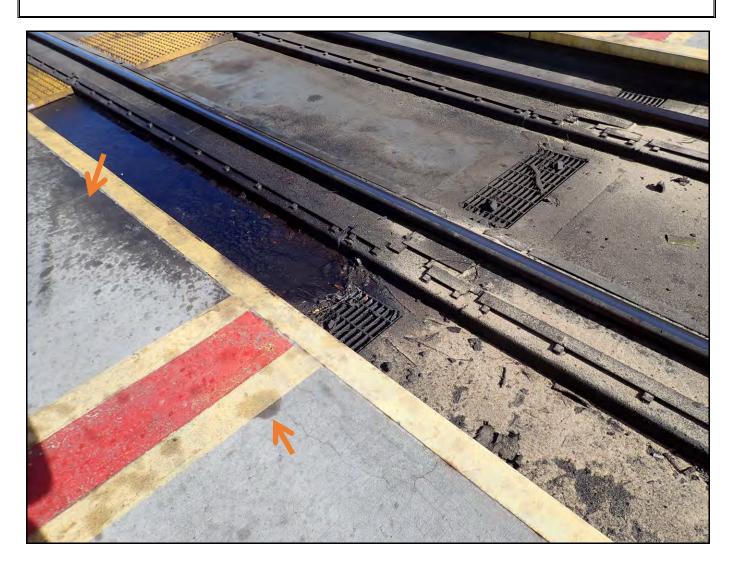
NMED/SWQB
Official Photograph Log
Photo # 6

Subject: Example of accumulated fluids and sand in track pan at industrial area West Bound Fueling Facility Rack (FA1). On-site representatives described preventative maintenance and schedule to keep track pans unclogged. Arrows point to examples of stains on concrete outside track pan.

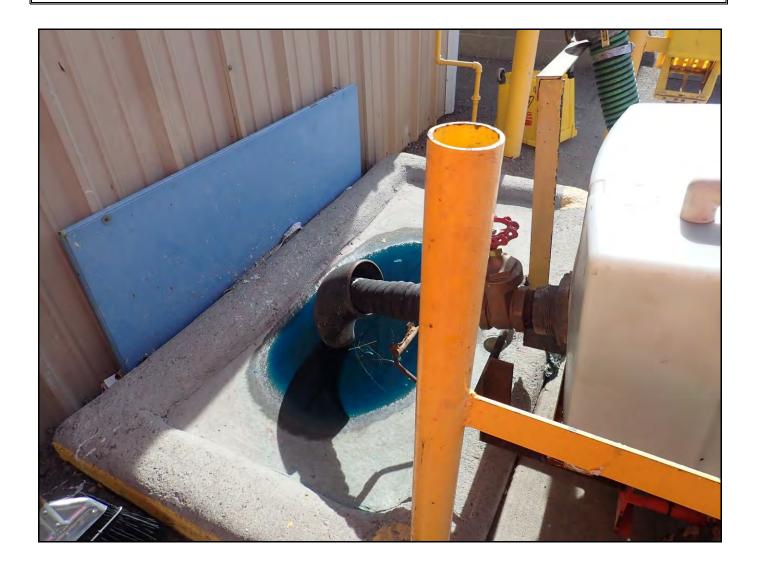
NMED/SWQB
Official Photograph Log
Photo #7

Subject: Exposed sanitary dump station used to dispose of wastes from cleaning locomotives near West Bound Fueling Facility Rack (FA1). Spilled or overflowed chemicals were contained within a concrete berm, but not promptly cleaned up as described in SWPPP.

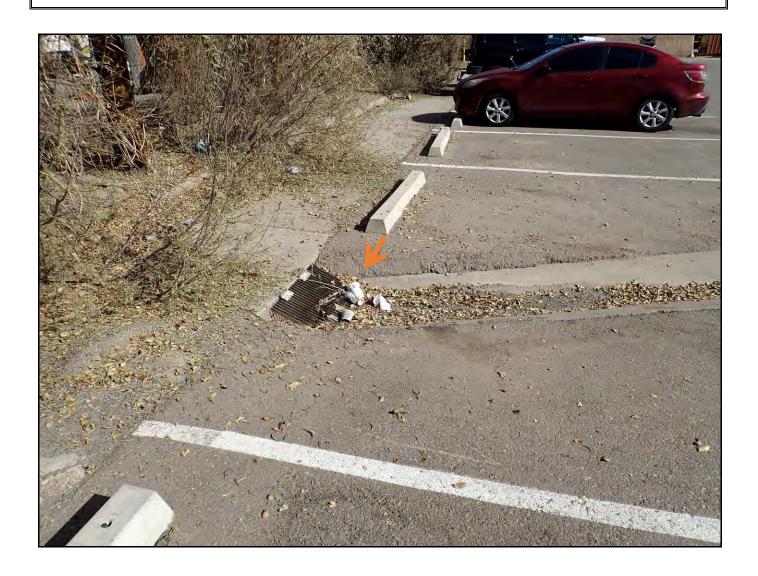
NMED/SWQB
Official Photograph Log
Photo #8

- O An observed drainage ditch/swale and inlet near the entrance to the 3.88-acre Depot area, north of the Industrial Activity West Bound Fueling Facility Rack/Area (FA1/FA3) were not shown/labeled on SWPPP Map 2 of 7. SPCC Map 2 of 9 shows direction of surface flow (by arrows) from the FA3 area toward the location of this ditch/swale inlet. SPCC Map 2 of 9 also did not show/label the inlet at the entrance to the Depot.

Subject: Arrow points to sediment and trash accumulated in a concrete swale and associated inlet grate in the northwest corner of the facility near the driveway for the Depot (Building 5). It was not determined during this inspection where water entering this inlet would flow.

Additional Notes: Inlet is not shown on SWPPP Map 2 of 7 and is not in an area that has industrial activity. The entrance is used to access areas with industrial activity. Runoff from industrial activity storage and vessel locations near the West Bound Fueling Facility Rack/ Fueling Area (FA1 and FA2) is shown (by arrows) toward the inlet location on SPCC Map 2 of 7. SPCC Map 2 of 7 shows/labels stormwater piping north of this inlet that is connected to the stormwater lift station, then grate outlet in open ditch which is MRGCD facility Santa Fe Ditch shown in next photo.

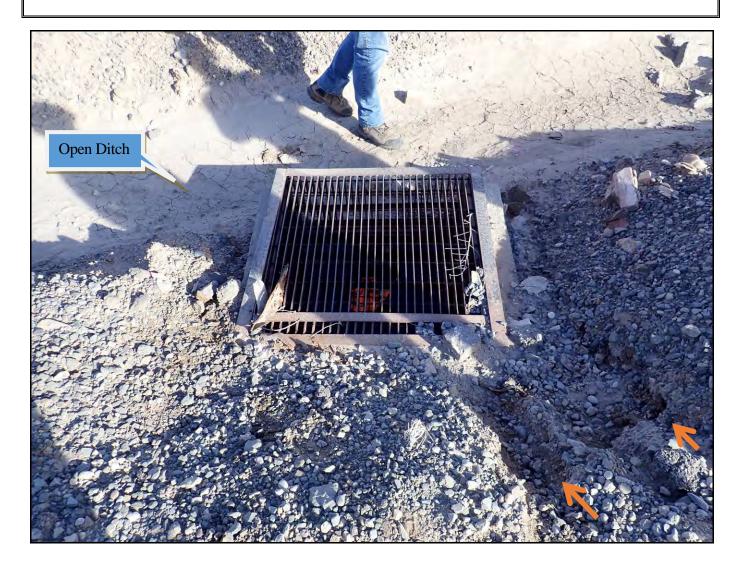
NMED/SWQB
Official Photograph Log
Photo # 9

Subject: In east portion of the facility, photo shows outlet grate set in concrete above open ditch, described as Outfall 002 or 2 on NOI, SWPPP, and SPCC. Permittee representatives described that flow from the grate overflows and enters the open ditch. Arrows point to erosion features on the slope to the outlet grate. The access road is above this location. Some debris was collected in grate. No substantial erosion or scour below the outlet was observed.

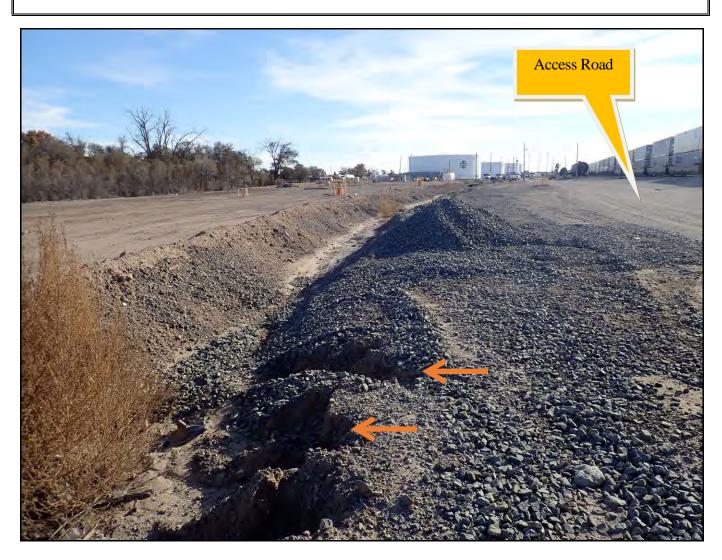
NMED/SWQB
Official Photograph Log
Photo # 10

Subject: Looking south-southeast along the east portion of the facility, course aggregate track ballast had been placed at erosion and/or low areas along edge of open ditch according to permittee representative. Some ballast was in bed of open ditch. Arrows point to erosion features at slope into open ditch. The open ditch, which is MRGCD facility Santa Fe Ditch, is adjacent to unpaved access road. This access road connects industrial activity maintenance areas to chemical and fuel storage and vessel locations on the east side of the facility.

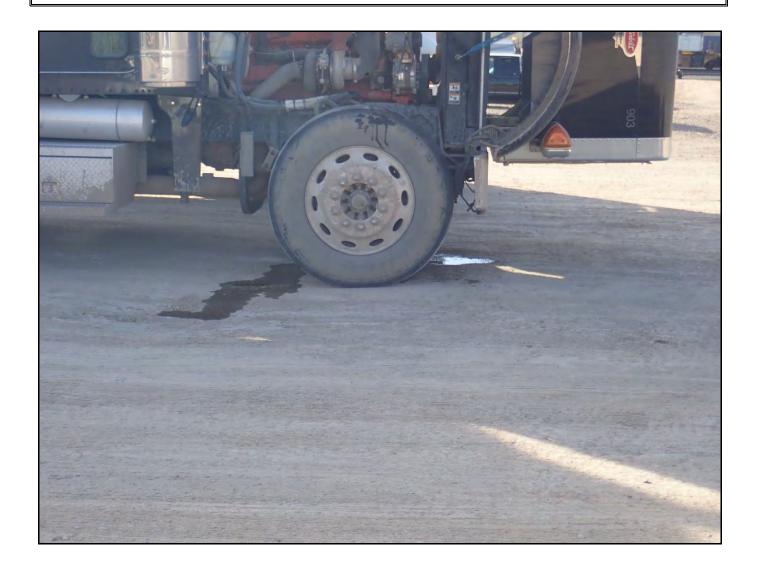
NMED/SWQB Official Photograph Log Photo # 11

Subject: Spill from on-site contractor's vehicle east of Red Dye Containment Area (FA14). The truck's hood was up, but there were no employees observed in close proximity to the vehicle when this photo was taken. Drip pan (not visible in photo) did not contain fluids. Permittee representatives described that the vehicle was not in a designated area for maintenance.

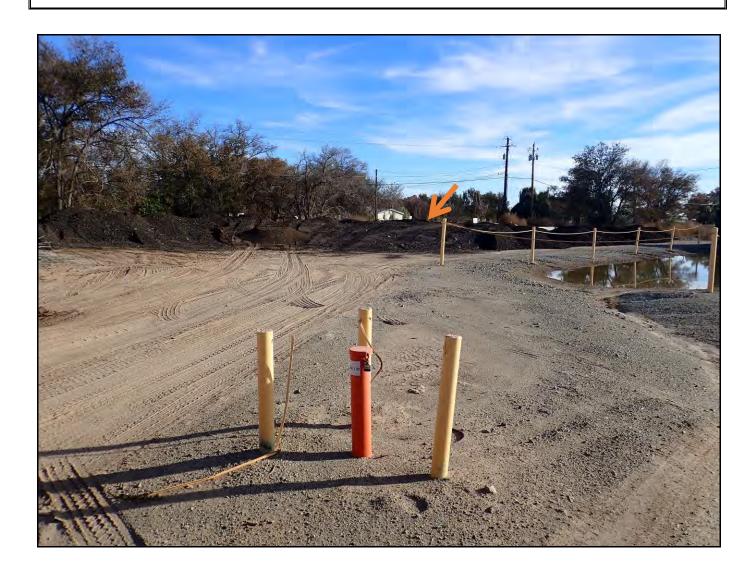
NMED/SWQB Official Photograph Log Photo # 12

Subject: The parking lot at the ATV vehicle and equipment maintenance area in the northeast portion of the facility was being milled and re-paved. Arrow points to asphalt milling stockpiles that were transported from the paving project to this location northeast of Red Dye Containment Area (FA14) at entrance from Jarales Road / Hwy 109. Concrete barriers are visible at entrance on SWPPP Page 3 of 7.

<u>Additional Notes</u>: Direction of surface flow (by arrows) shown on SPCC Map Page 3 of 9 over the low area with ponded water in the right side of this photo is not consistent with observed topography.

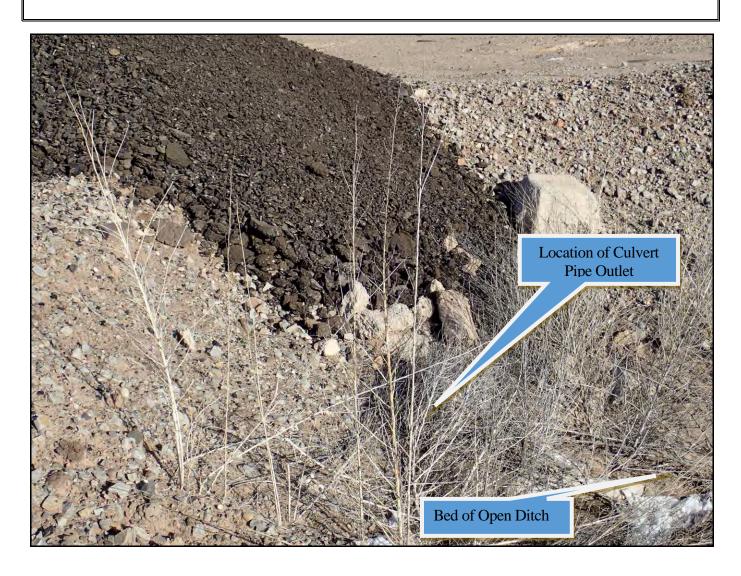
- SWPPP Maps did not show Santa Fe Ditch ditch/swale piped to area east of Red Dye Containment Area (FA14) on Map 3 or continuing south on Maps 4 and 5. SPCC Map 3 of 9 appears to incorrectly show Santa Fe Ditch piping as Industrial Wastewater (IW) piping to area east of aboveground storage of Red Dye Flammable Kerosene and Lubricity Combustible Corrosive (A9 and A10).

Subject: Milling from the stockpile area shown in previous photo continues into and down the side of the open ditch where the culvert pipe shown in Photo #13 has an outlet east of Red Dye Containment Area (FA14). Arrow is the location of the culvert pipe outlet which is obscured by vegetation. Paper trash was observed in bed of Santa Fe Ditch.

Additional Notes: SWPPP Maps 3, 4 and 5 do not show/label the location of MRGCD facility Santa Fe Ditch from the culvert pipe inlet, pipe outlet, the continuing as open ditch / swale. SPCC Map 3 of 9 shows/labels the MRGCD facility Santa Fe Ditch from the approximate location of the culvert pipe inlet, thru to the culvert pipe outlet and open ditch as Industrial Wastewater (IW) pipe. SPCC Map 3 shows/labels the MRGCD facility Santa Fe Ditch continuing as IW pipe into ditch/swale.

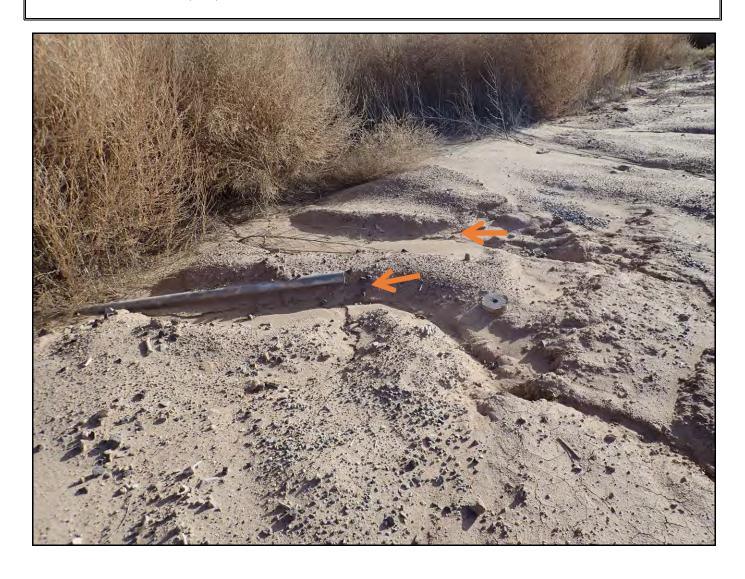
NMED/SWQB
Official Photograph Log
Photo # 14

Subject: Arrows point to erosion features above vegetated MRGCD facility Santa Fe Ditch east of the access road east of the South Main Tank Farm (FA4).

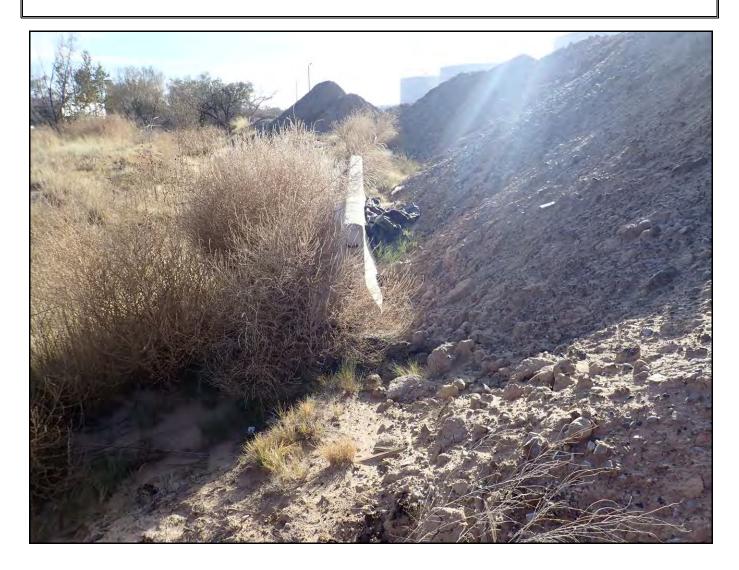
NMED/SWQB		
Official Photograph Log		
Photo # 15		
11/14/2018	Time	1500

Subject: Stockpiled earthen material adjacent to MRGCD facility Santa Fe ditch. Concrete barrier (backstop) did not

continue along length of stockpile.

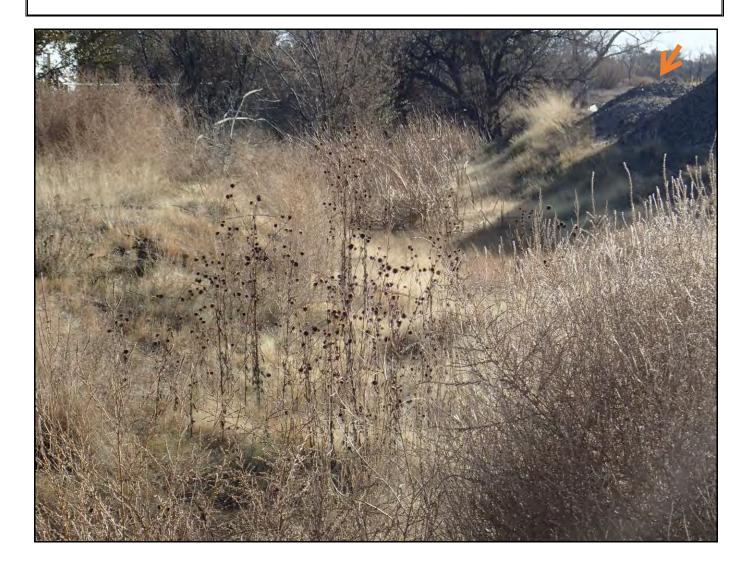
Subject: Vegetation in MRGCD facility Santa Fe Ditch. Arrow points to stockpiled earthen material adjacent to

ditch/swale.

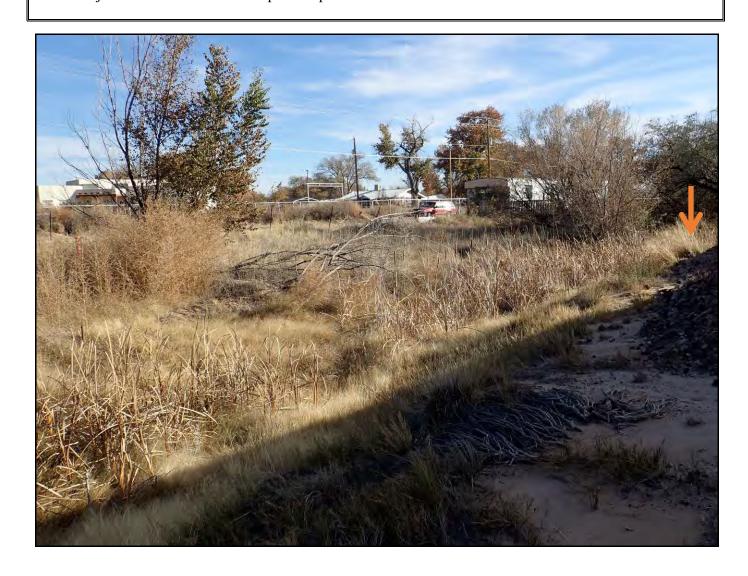
NMED/SWQB
Official Photograph Log
Photo # 17

Subject: Vegetation, including cattails, in MRGCD facility Santa Fe Ditch. Arrow points to slope of stockpiled earthen material adjacent to ditch/swale shown in previous photo.

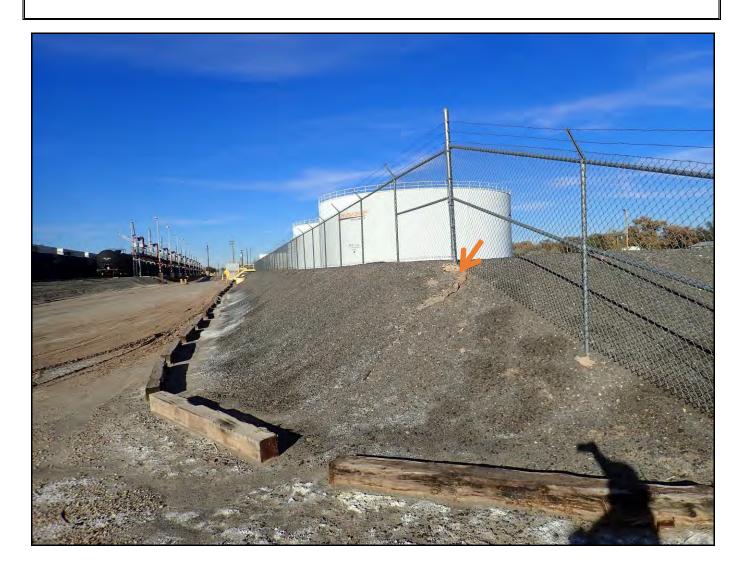
NMED/SWQB
Official Photograph Log
Photo # 18

Subject: Arrow points to example of shallow erosion feature on embankment of containment liner at southwest corner of above-ground fuel storage (South Main Tank Farm). Similar shallow erosional features were observed on west and south sides of the embankment.

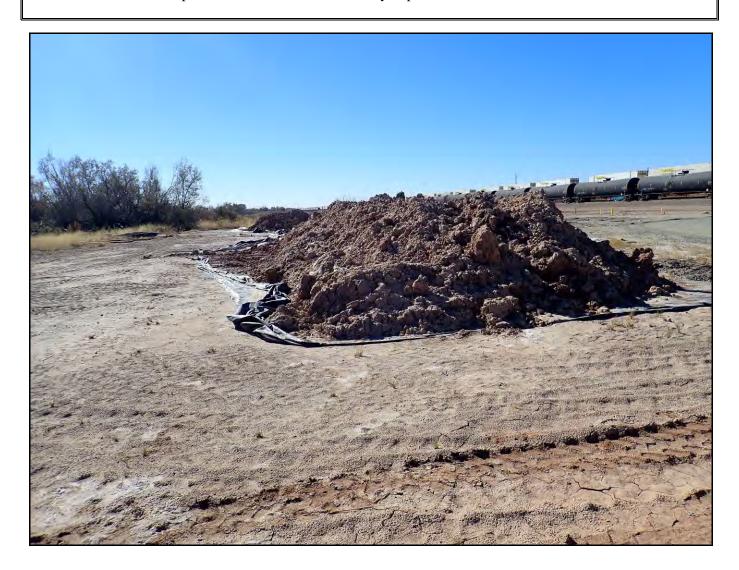
Subject: Permittee representatives described that this stockpile on plastic sheeting included soils impacted by July/August oil/water separator release and over excavation to enlarge the impacted retention pond. Soils impacted by the August runoff from the oil/water separator release were not immediately disposed off-site.

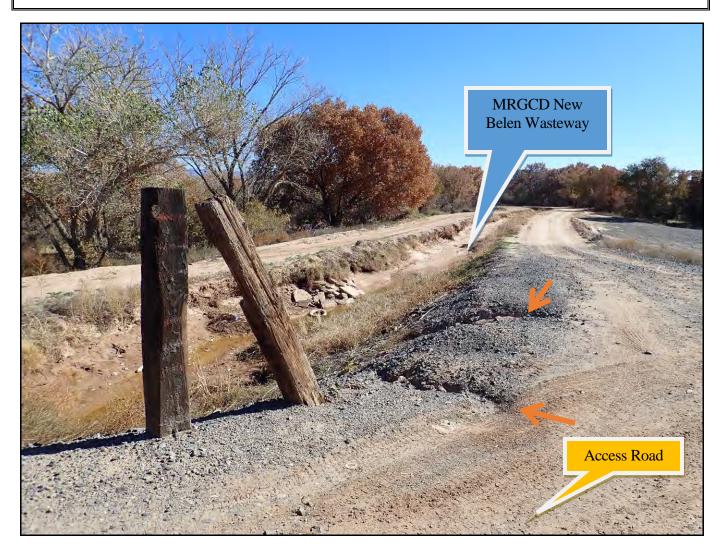
NMED/SWQB Official Photograph Log Photo # 20		
Photographer: Erin S. Trujillo	Date: 11/15/2018	Time: 1214 hours
City/County: Belen / Valencia County, New Mexico		State: New Mexico
Location: BNSF Railway Company, Belen Yard		
Subject: Arrows point to erosion features from and near access road at MRGCD facility New Belen Wasteway.

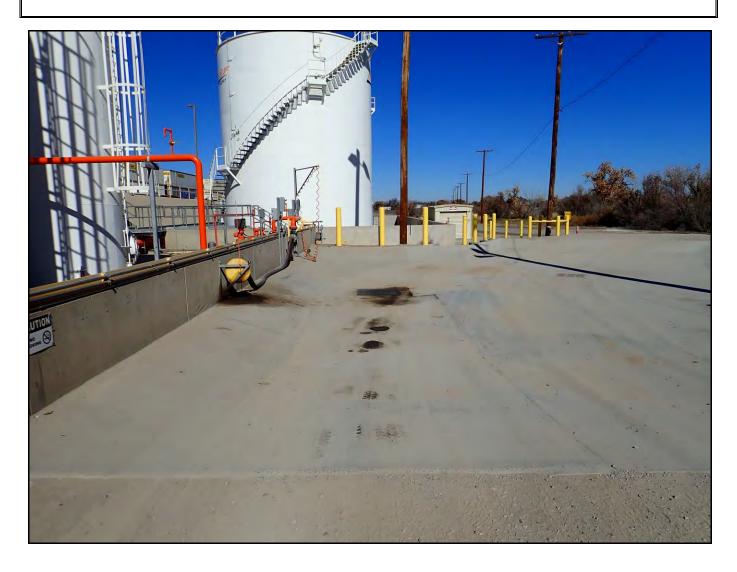
Subject: Example of stains and inlet grates at oil aboveground storage tanks east of East Bound Fueling Facility (FA10 and FA5, respectively). Inlet grates are in a concrete swale or low area.

<u>Additional Notes</u>: SPCC Map 5 of 7 shows/labels underground piping, but industrial wastewater (IW) piping is not shown/labeled for area east and north of East Bond Fueling Facilities. IW piping is not shown on SWPPP Map 5 of 7.

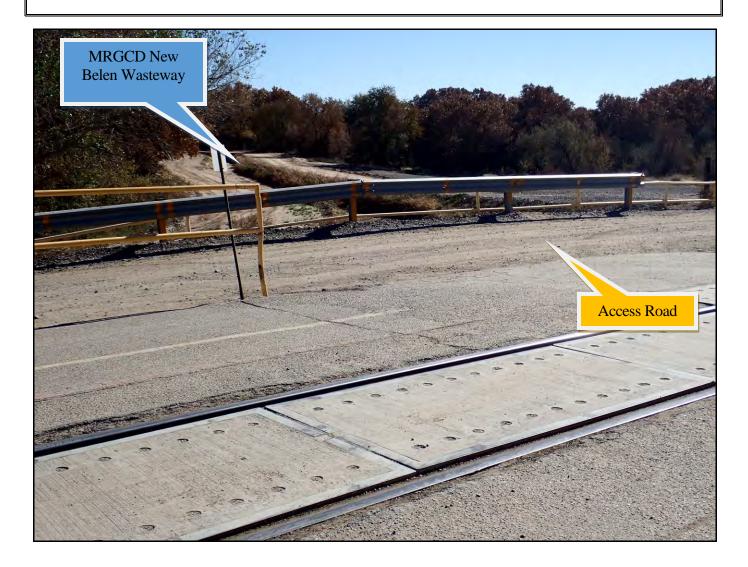
NMED/SWQB
Official Photograph Log
Photo # 22

Subject: Looking east-southeast at access road and MRGCD facility New Belen Wasteway from eastern end of Eastbound Fueling Facility (FA5).

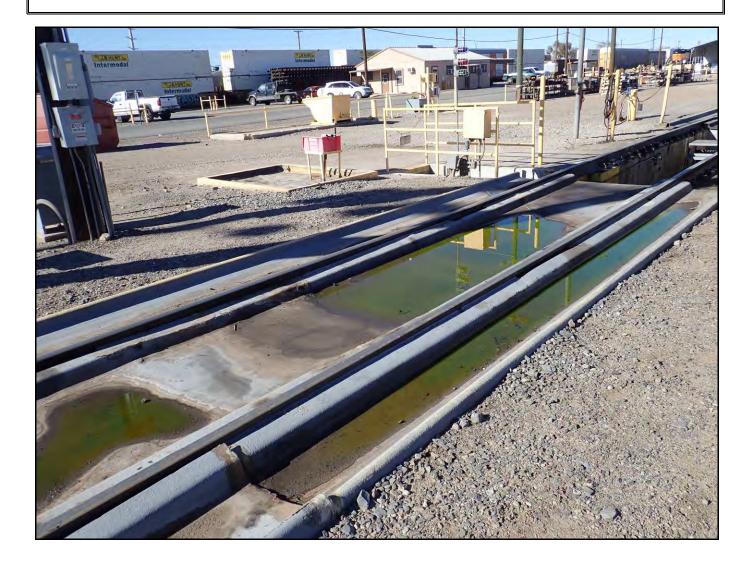
Subject: Spilled or overflowed fluids were contained within track pan at maintenance area / inspection pit., but not

promptly cleaned up as described in SWPPP.
